Allison transmissions: outstanding in any field, even those flooded

Locals rebuild Raba-Steiger tractors with Allison fully automatic transmissions for efficient, reliable performance even during heavy flooding

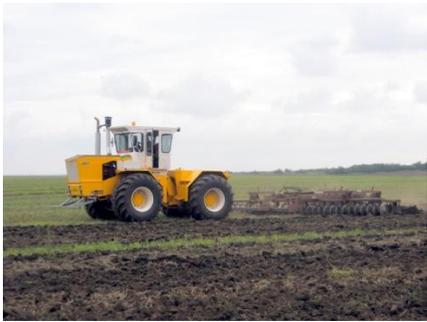
<p>© Allison Transmission</p>	<p>Allison patented torque converter technology protects the driveline and the CAN controller moderates engine torque based on other system data and operating conditions. This ensures, that the original vehicle parts are not overworked – crucial to keeping maintenance costs low and extending the vehicle's life.</p>

Allison patented torque converter technology protects the driveline and the CAN controller moderates engine torque based on other system data and operating conditions. This ensures the original vehicle parts are not overworked – crucial to keeping maintenance costs low and extending the vehicle's life.

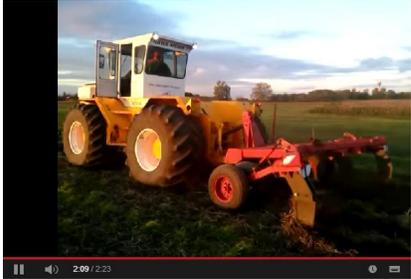
<p>Huntractor HT300 Mélylazítózik © Allison Transmission</p>	<p>Video: YouTube https://www.youtube.com/watch?v=UDdpWiWg9SI</p> <p>Huntractor HT300 works the land. Deep loosening was not a problem, with the Allison fully automatic transmission assuring continuous power.</p>

Towing cultivating discs through the soil is a very challenging process depending on the quality of the land. Compared to the original driveline, the Allison-equipped Huntractor HT300 achieved a 25 to 30 percent reduction in fuel consumption. The HT300 was tasked with deep-loosening. Dragging loosening-plows through flooded land is the same as operating with a heavy load, yet the tractor launched smoothly and performed without any jerks to produce a uniformly tilled field.

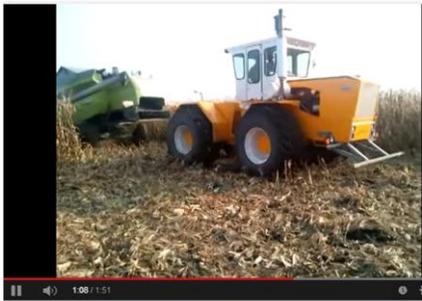
<p>Huntractor HT300</p>	<p>Video: You Tube https://www.youtube.com/watch?v=ZYFZ7MVdRWw https://www.youtube.com/watch?v=OdMI9H34L9A</p> <p>Huntractor HT300 pulls sunken agricultural machines out of previously flooded fields.</p>

Due to high levels of precipitation in South and Central Europe in 2014, agricultural machines across the continent were stuck in the mud. But with its Allison fully automatic transmission, the Huntractor HT300 did not experience the same downtime. In fact, it was often sent to retrieve stranded vehicles, which it did without becoming mired down itself.
